NAUGATUCK RIVER BASIN
WATERTOWN, CONNECTICUT

**PIN SHOP POND DAM
CT 00127**

**PHASE I INSPECTION REPORT
NATIONAL DAM INSPECTION PROGRAM**

JANUARY 1981

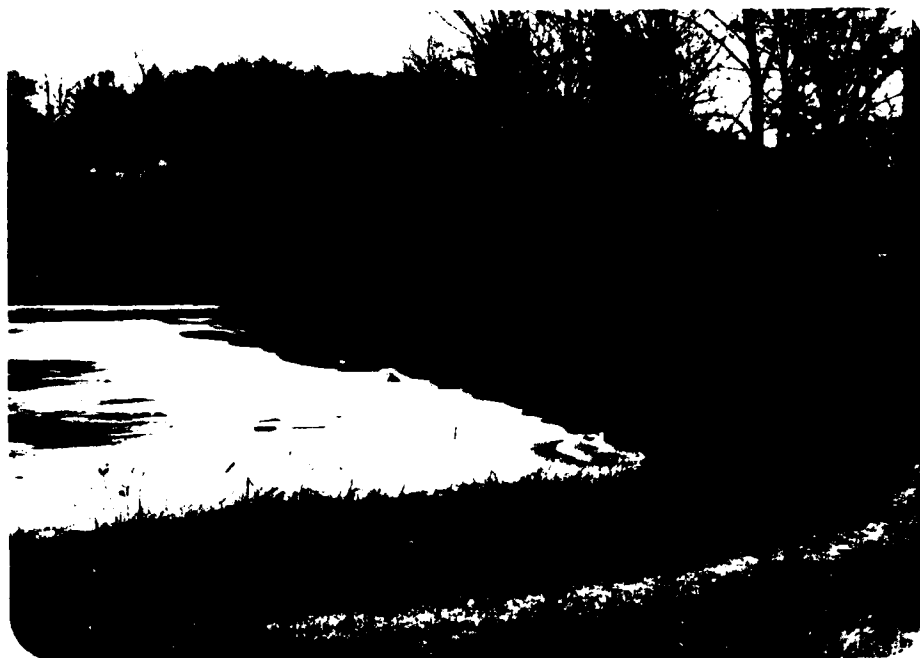
PHOTO NO. 3

The upstream slope of the dam is overgrown with numerous trees up to 8-inches in diameter, Photo 3. There is no riprap slope protection present, and considerable erosion has taken place at and above the normal water line, Photo 4. The crest is fairly level and is covered with grass, brush and small trees, Photo 1. An erosion path is worn at about the centerline of the crest. The downstream slope is covered with numerous trees up to 12-inches in diameter, Photo 5. The slope is relatively steep in some areas and has an average slope of about 1.5 horizontal to 1 vertical. Several erosion paths are present on the downstream slope, including one at the left end of the earth embankment which cuts back into the crest and measures approximately 5 feet wide and 5 feet deep, Photo 6. Near the center of the earth embankment at the top of the downstream slope there are two small concrete piers which serve no apparent purpose at the present time. There was no seepage observed on either the downstream slope or in the area immediately downstream of the dam.

UPSTREAM SLOPE FROM RIGHT ABUTMENT.
NOTE TREES.

1. Design repairs for the eroded areas of the upstream and downstream slopes of the embankment.
2. Design slope protection for the upstream and downstream slope of the dam.
3. Remove trees, stumps and root systems from the slopes and crest of the dam and in the area within 20 feet of the downstream toe, and backfill with proper material.
4. Investigate the undermining of the spillway apron and recommend remedial measures.
5. Investigate the condition of the spillway training walls and oversee removal of vegetation from open joints in the masonry, and repair of the joints.
6. Investigate the condition and capacity of the outlet works and recommend remedial measures to make the outlet works operable.
7. Perform a detailed hydrologic and hydraulic analysis in order to determine the need for and means to provide additional project discharge capacity.

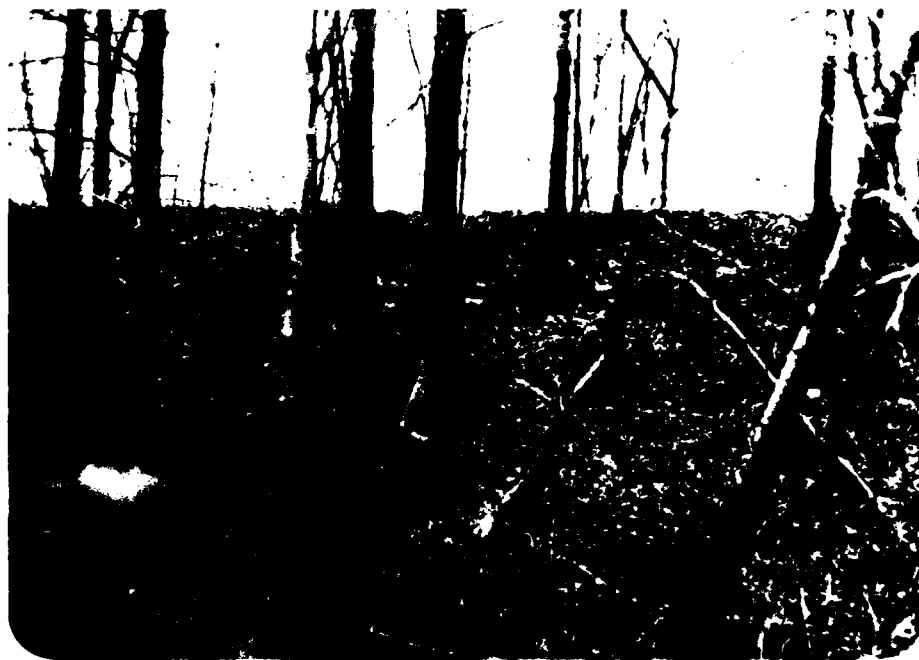
PHOTO NO. 5

TREES ON DOWNSTREAM SLOPE OF DAM

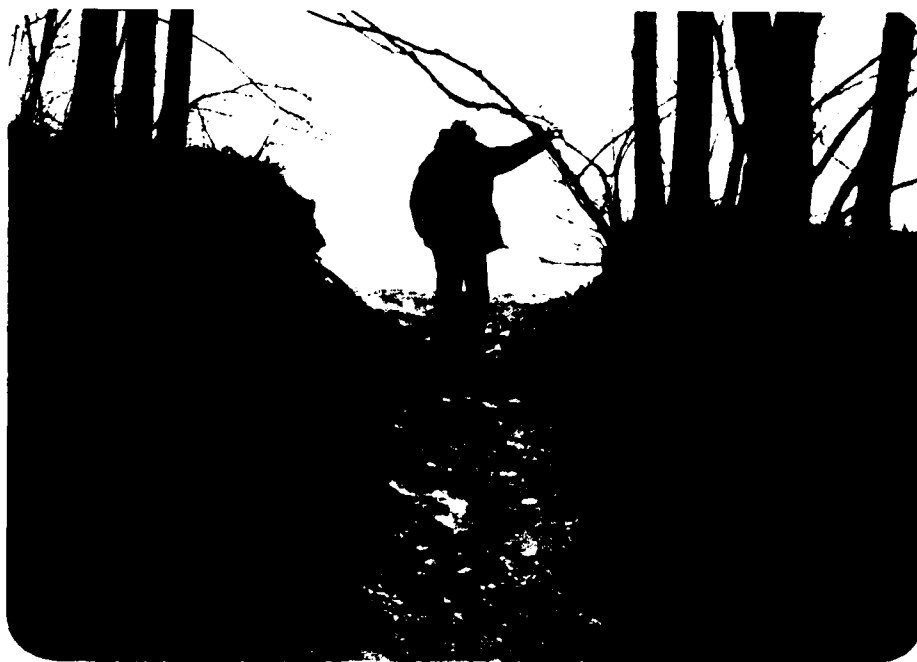
PHOTO NO. 6

EROSION GULLY AT LEFT END OF
EARTH EMBANKMENT.
